General Statement

The Sinclair Park Community Center Building was a concrete block structure with wood frame detailing and steel compound trusses spanning a primary assembly hall. The building reflected mid 20th Century design ideas that emphasized low, flat roof profiles, generous patterns of windows and fenestration and an absence of architectural ornamentation. As a public assembly facility and social center, the building represented a physical center for the residential neighborhood. As one of the first projects, if not the first, project, by Naramore, Bain, Brady & Johanson, an architecture firm that subsequently rose to national prominence, the building constituted an important marker in the firm's history. Following the close of World War II, the more fragile small wood frame buildings that comprised the neighborhood disappeared by 1948, leaving the Community Center isolated on a hillside setting overlooking the neighborhood's namesake, Sinclair Inlet.

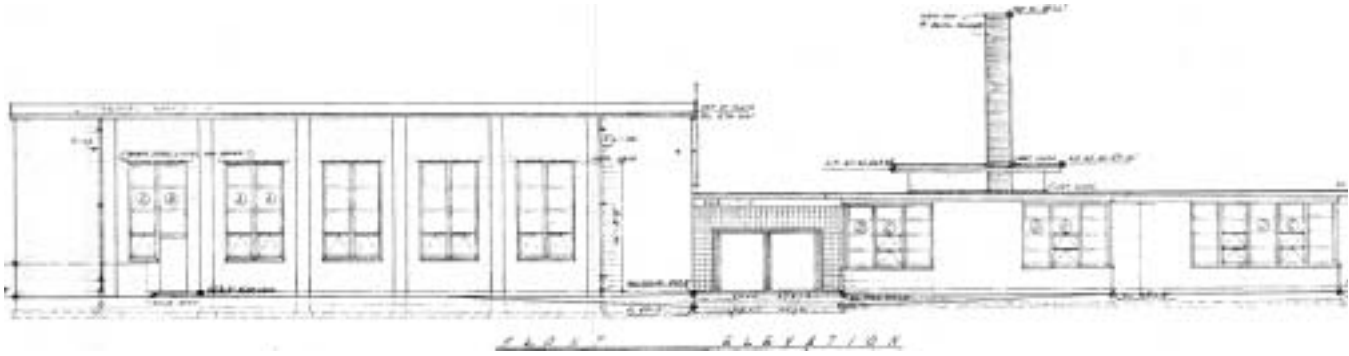
EAST (PRIMARY) ELEVATION. UNDATED DRAWING COURTESY OF THE WASHINGTON MILITARY DEPARTMENT.

The main entry to the Community Center was centrally placed on the front (east) facade and was flanked by the only prominent decorative element on the building--a glass block archway around the main doors. This principal public access to the building was the primary visual organizing element on the exterior of the structure and gave the building a modest sense of importance. Secondary entries were located on all facades, providing service access and egress.

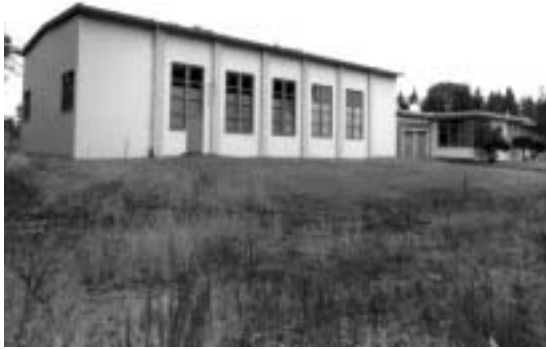
VIEW LOOKING NORTHWEST AT PRIMARY FACADE. PHOTOGRAPH BY TERRY RISHEL (SEPTEMBER 2002).

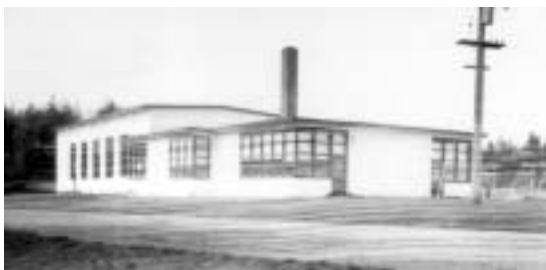
VIEW LOOKING SOUTHWEST AT PRIMARY FACADE. PHOTOGRAPH COURTESY OF THE WASHINGTON MILITARY DEPARTMENT (CIRCA LATE 1950S).

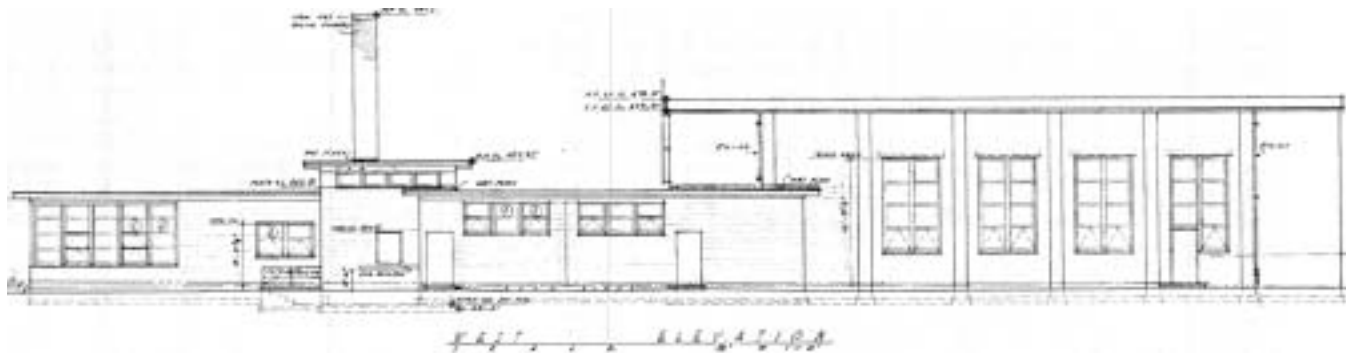
WEST (BACK) ELEVATION. UNDATED DRAWING COURTESY OF THE WASHINGTON MILITARY DEPARTMENT.

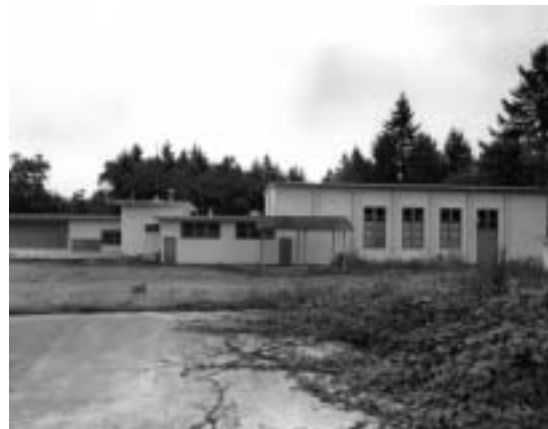
VIEW LOOKING EAST AT BACK FACADE. PHOTOGRAPH BY TERRY RISHEL (SEPTEMBER 2002).

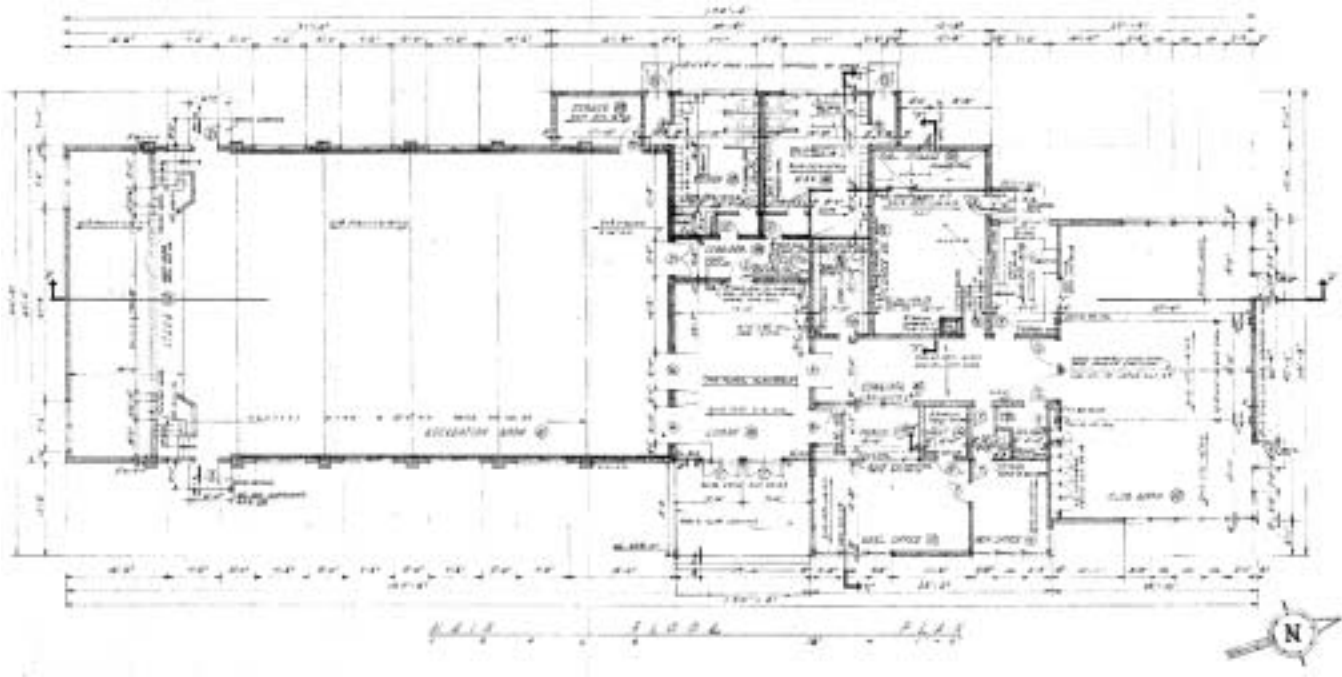
FLOOR PLAN. UNDATED DRAWING COURTESY OF THE WASHINGTON MILITARY DEPARTMENT.

The footprint of the two-story section was a simple rectangle, while the one-story portion, which contained a more varied building program, consisted of two rectangular blocks on the portion's north and south ends, offset slightly from one another, with a wedge between them. A north-south connecting corridor between the blocks bisected the wedge into two smaller rectangular volumes. The prominent wider east end of the wedge projected out from the front facade with the tapered west end forming a rectangular shed roofed volume that projected slightly above the one-story roofline.

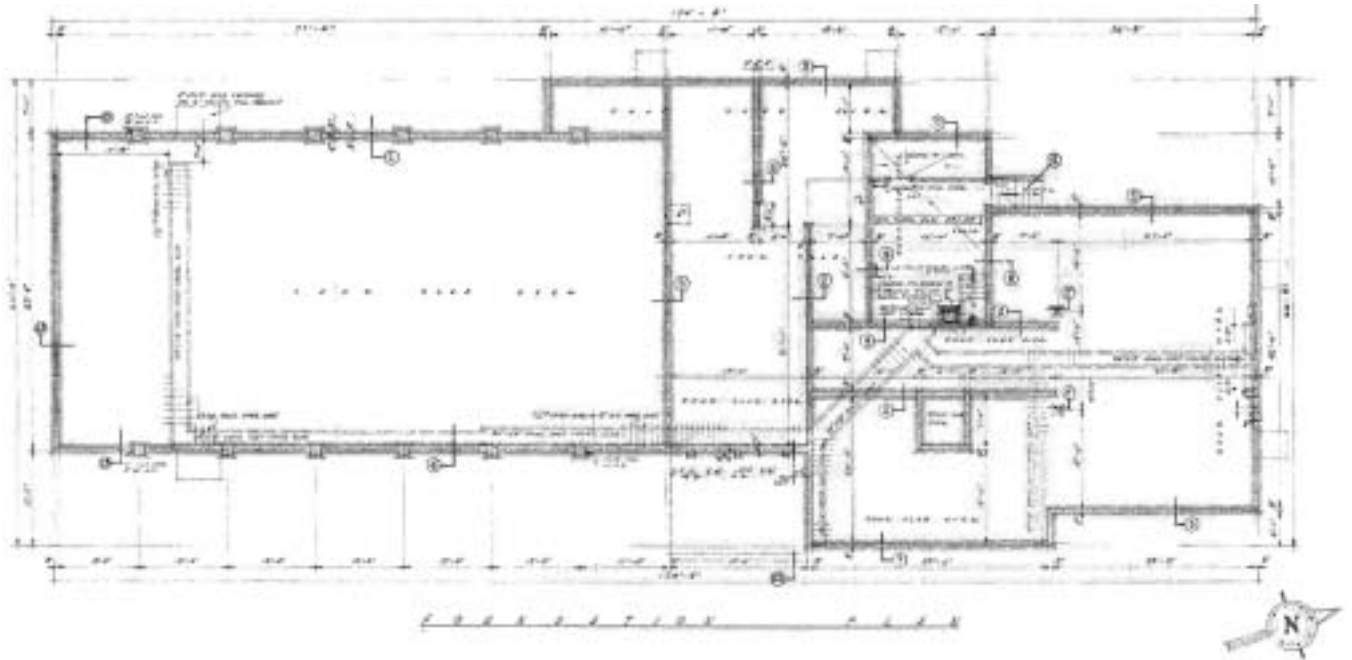
FOUNDATION PLAN. UNDATED DRAWING COURTESY OF THE WASHINGTON MILITARY DEPARTMENT.

The building's substructure consisted of a concrete foundation with spread footings averaging 1'-8"x6" in width and depth. The footings widened to 2'-4" below the truss columns of the two-story volume. Between the foundation walls, concrete slabs on grade formed the sub flooring. Metal bars (½" in diameter) set into the concrete on 12" centers reinforced the slabs over the recessed ductwork.

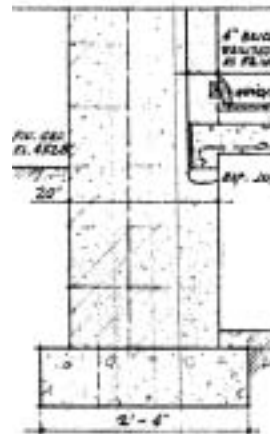
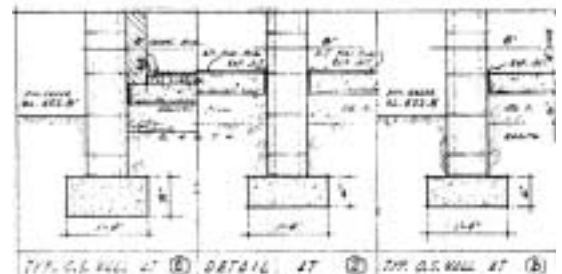
FOUNDATION DETAILS AT TYPICAL WALLS (BELOW) AND OF TRUSS COLUMNS (LEFT). UNDATED DRAWINGS COURTESY OF THE WASHINGTON MILITARY DEPARTMENT.

Truss columns placed six to a side on 12'-4" centers along the recreation room's east and west walls carried the overhead load of metal trusses and wood roof framing. These 20"x20" truss columns consisted of un-reinforced 8" concrete block. In the clubroom, 10"x10" wood columns set back on either side of the doorway to the corridor provided additional support for the room's ceiling joists.

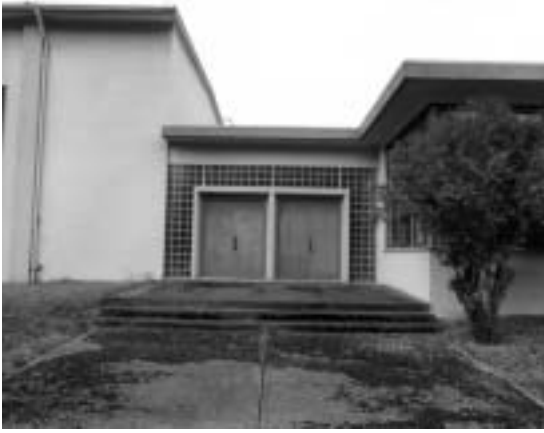
MAIN ENTRY. THE DOORS ARE CONTEMPORARY REPLACEMENTS. PHOTOGRAPH BY TERRY RISHEL (SEPTEMBER 2002).

The approach to the main entry consisted of a sidewalk leading to a 19'-0"x13'-5" concrete slab landing at grade. The doorway featured a reinforced concrete door frame and mullion with a

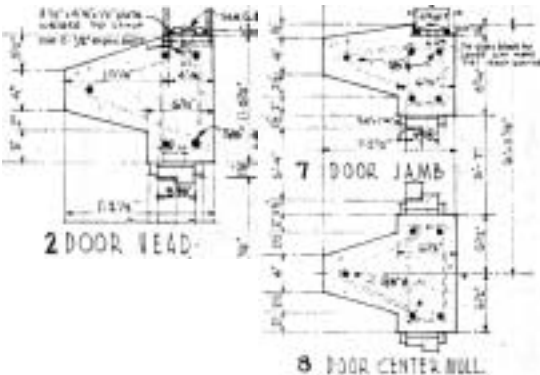
DETAILS OF MAIN ENTRY DOOR HEAD, JAMB AND CENTER MULLION SHOWING TAPER. UNDATED DRAWING COURTESY OF THE WASHINGTON MILITARY DEPARTMENT.

glass-block surround. Both the frame and mullion projected outward approximately 8" in a taper ending in a flat 4" wide face. A more pronounced taper accented the inner faces of the jambs and lintel with only a relatively slight taper on the outer faces. Both faces of the mullion between the doors featured an equal taper. Within this framework hung two sets of 2'-8"x7'-0" wood, three-lite, flush panel, double doors. Metal ties secured the 4" glass-block to the outer side of the concrete framework and to the exterior building walls. Both the use of glass-block and minimal decorative detailing reflected Art Moderne influences.

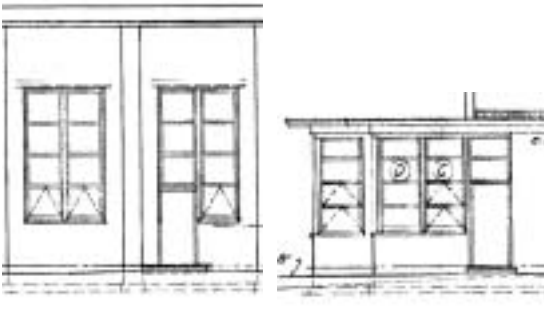
DETAILS OF DOORWAY INTEGRATION WITH WINDOW OPENINGS INTO RECREATION ROOM (LEFT) AND CLUBROOM (RIGHT). UNDATED DRAWING COURTESY OF THE WASHINGTON MILITARY DEPARTMENT.

Particularly interesting was the integration of service entries within the dominant pattern of window openings. On the recreation room's east and west sides, the upper portions of the doorways replaced one of the lower lites. Similarly, the two entries on the north end of the clubroom each occupied the bottom two lites of the respective window composition. Combining window and door openings beneath one lintel made efficient use of the limited wall surface available for openings in these particular areas.

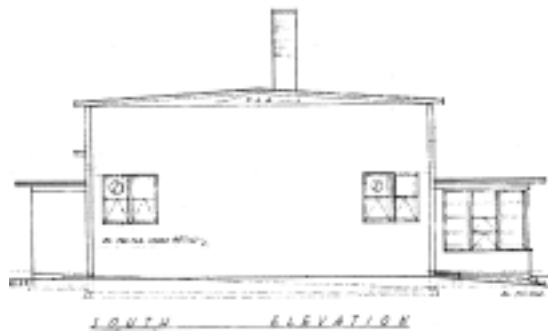
SOUTH ELEVATION SHOWING WINDOWS INTO RECREATION ROOM. UNDATED DRAWING COURTESY OF THE WASHINGTON MILITARY DEPARTMENT.

The two-story volume's east and west facades featured tall pairs of windows placed approximately 5' above grade, each having nearly square lites. Each pair occupied a bay between the truss columns. The south end wall of the building featured two sets of two-lite windows. Awning lites across the bottom on the east and west facades as well as the south end-wall provided ventilation.

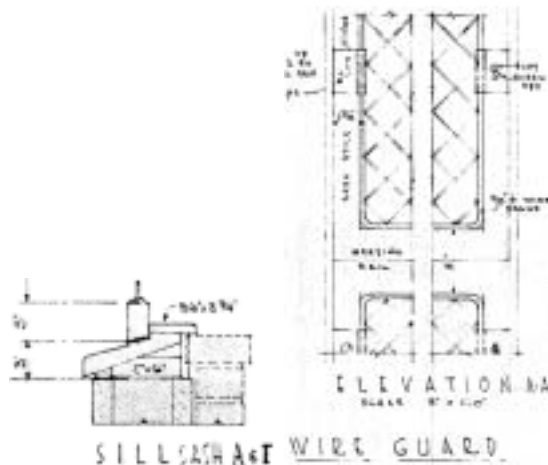
DETAIL (ABOVE LEFT) OF SILL ON WINDOWS IN THE RECREATION ROOM WITH BRICK VENEER AND WIRE WINDOW GUARDS (ABOVE RIGHT). UNDATED DRAWING COURTESY OF THE WASHINGTON MILITARY DEPARTMENT.

The wood framing for these windows set within the window openings, with the wood sill, and interior casings and apron built-up above the concrete block walls. In the recreation room, the 3¾" wide inner sill lapped slightly over the brick wainscot. Wire

guards mounted on the interior of the recreation room windows protected each lite. Side hinges on the guards allowed them to open to clean the glass.

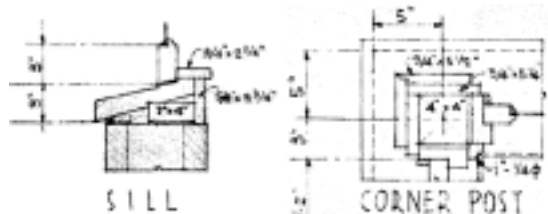
DETAIL (LEFT) OF SILL ON WINDOWS AND BUILT-UP CORNER POSTS (RIGHT) IN THE ONE-STORY PORTION. UNDATED DRAWING COURTESY OF THE WASHINGTON MILITARY DEPARTMENT.

The wood window framing for these windows—similar to the framing in the two-story volume—set within the window openings with the 2¾" wide wood inner sill and 3¾" apron built-up above the concrete block.

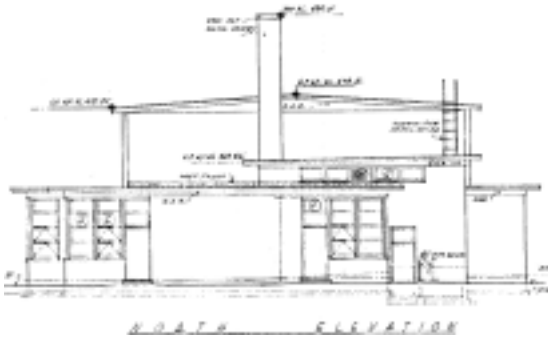
NORTH ELEVATION SHOWING WINDOWS INTO CLUBROOM AND CLERESTORY OVER THE FURNACE ROOM. UNDATED DRAWING COURTESY OF THE WASHINGTON MILITARY DEPARTMENT.

Service area windows on the west facade were minimal, consisting of those into the kitchen and bathrooms, and a clerestory band above the one-story roofline bringing light into the furnace room. Windows into the kitchen and bathrooms featured a single upper fixed lite with an awning lite below. On the clerestory, the side-hinged lite on the south side above an interior ladder enabled access to the roof.

Wood, cloth backed louvers in the clerestory together with the windows on the north and south sides ventilated the furnace room.

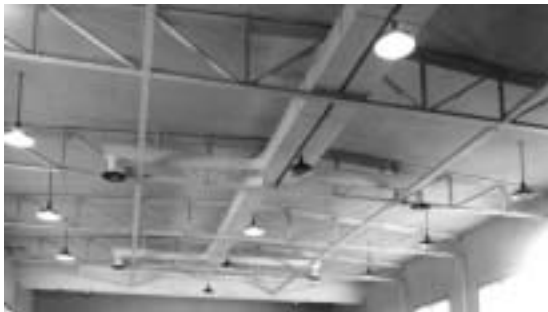
VIEW OF EXPOSED TRUSSES IN RECREATION ROOM LOOKING SOUTH (DETAIL BELOW). PHOTOGRAPH BY TERRY RISHEL (SEPTEMBER 2002).

Steel, sloped chord, modified Pratt trusses on 12'-4" centers spanned the two-story block with ¾" diameter tie rods between every other bay to prevent lateral buckling. The trusses tapered from a 3'-8¾" center height to 2'-0" high ends with an overall 1" camber. The connections between the trusses and the concrete

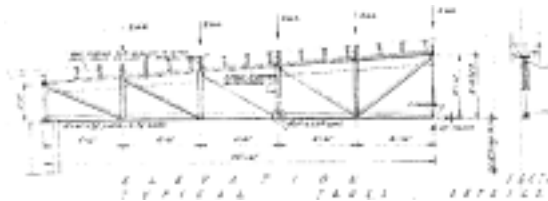
TRUSS DETAIL. UNDATED DRAWING COURTESY OF THE WASHINGTON MILITARY DEPARTMENT.

block columns relied on 6"x6"x $\frac{7}{8}$ " metal plates anchored with 4½" diameter pins to the tops of the truss columns and secured to the trusses with four 2¾" bolts. Running perpendicular to the trusses, two 4"x4" I-beams connected between the bottom chord of each truss added lateral rigidity.

A 2"x6" board bolted to the top chord of the trusses provided anchorage for the 2"x8" purlins spaced on 16" centers and sheathed with gypboard. Reinforcing the connection between the trusses and outer layer of roof framing were 14" long U-shaped straps welded to the top chord of the trusses into which the vertical members tied. They then fastened with ½" bolts to the corresponding purlins to tie the wood roof framing to the metal trusses.

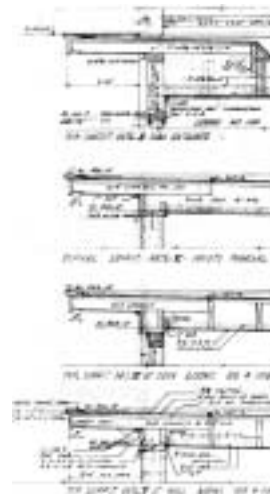
DETAIL OF ROOF FRAMING SHOWING INTEGRATION OF LOOKOUTS AROUND THE ONE-STORY ROOF PERIMETER. UNDATED DRAWING COURTESY OF THE WASHINGTON MILITARY DEPARTMENT.

Around the perimeter of the one-story roofline, the lookouts having a ¼" to 1" pitch formed a continuous and uniform band along the edge of the roof. These lookouts were sheathed in 1" gypboard.

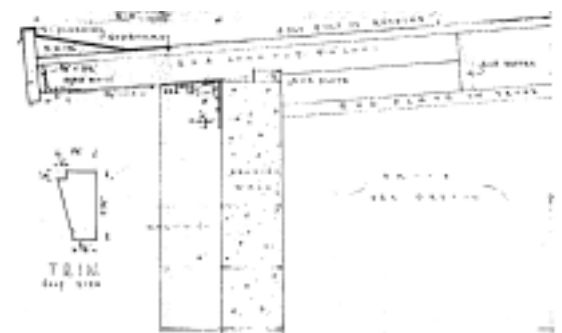
FIG. 21. DETAIL OF ROOF FRAMING ON THE RECREATION ROOM. UNDATED DRAWING COURTESY OF THE WASHINGTON MILITARY DEPARTMENT.

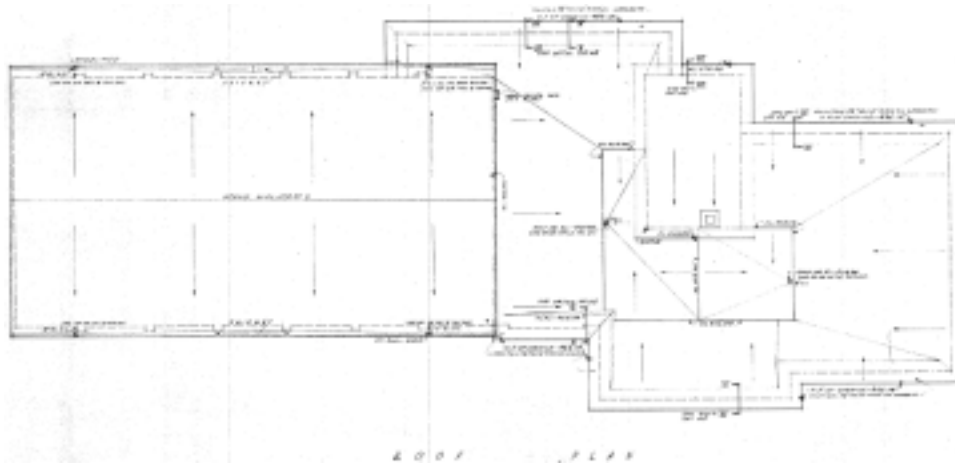
ROOF PLAN INDICATING DRAINAGE. UNDATED DRAWING COURTESY OF THE WASHINGTON MILITARY DEPARTMENT.

Drainage for the two-story volume consisted of crickets behind the built-up fascia that directed water to metal 3" in diameter downspouts at either end of the building. These downspouts channeled the water to drains that led away from the building to subterranean gravel pockets.

On the one-story volume, the back slope of the roof directed water to two central interior 4" in diameter roof drains. The internal downspouts led to drains that ran beneath the floor slab of the clubroom and the men's toilet, respectively, to subterranean gravel pockets on the building's west side. Metal flashing sealed the joint between the north wall of the two-story volume and the roof over the one-story volume.

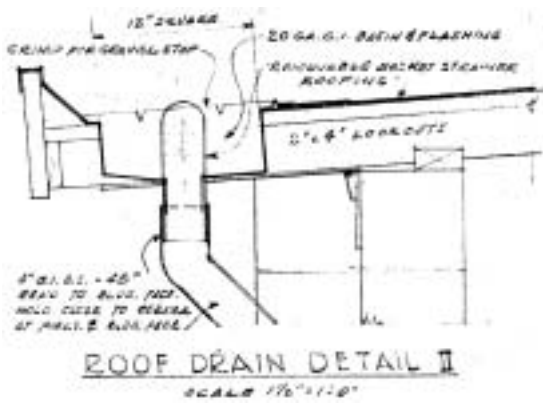
DETAIL OF ROOF DRAIN ON TWO-STORY PORTION. UNDATED DRAWING COURTESY OF THE WASHINGTON MILITARY DEPARTMENT.

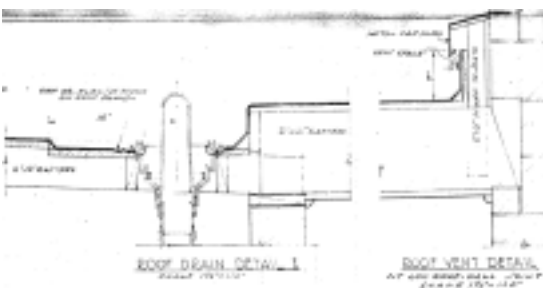
DETAIL OF ROOF DRAIN TO INTERNAL DOWNSPOUT ON ONE-STORY PORTION. UNDATED DRAWING COURTESY OF THE WASHINGTON MILITARY DEPARTMENT.

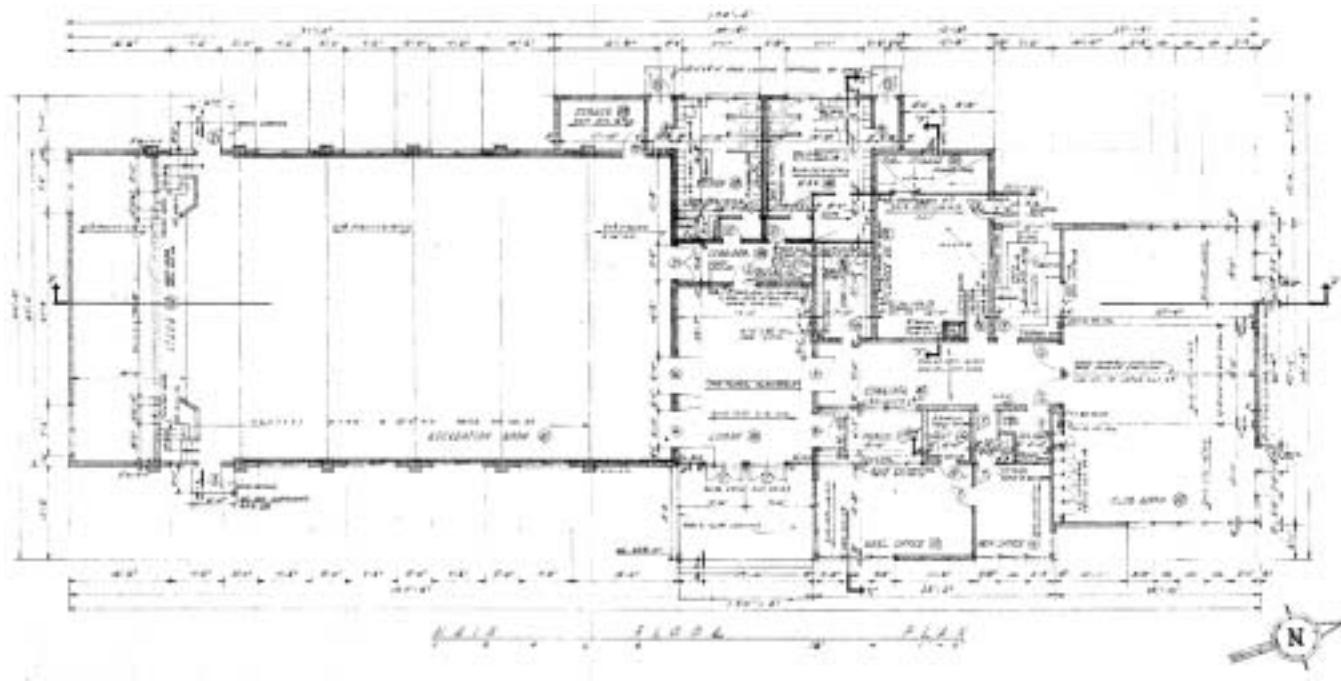
FLOOR PLAN. UNDATED DRAWING COURTESY OF THE WASHINGTON MILITARY DEPARTMENT.

Within the overall layout of the building, the 19'-0"x25'-9" lobby provided a three-way transition point for the public entering the building. From this lobby, double doors led to the recreation room (south), to the public area of the general office (north), and to the corridor that led to the clubroom (north). The relative alignment of these doors with one another facilitated flow between these spaces. Opposite the main entry, a single door on the west led to the secondary corridor and the bathrooms. Within the lobby, the ceiling sloped down from the recreation room towards the corridor, imparting additional emphasis on the north-south flow across the lobby between the recreation room

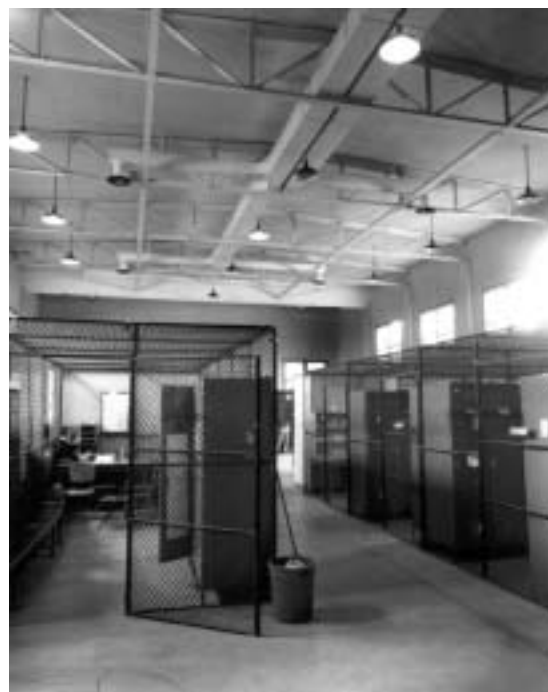
RECREATION ROOM, LOOKING SOUTH. WIRE CAGES WERE CONTEMPORARY ADDITIONS FOR STORAGE AND OFFICE SPACE. PHOTOGRAPH BY TERRY RISHEL (SEPTEMBER 2002).

The interior volume of the 88'-0" x 45'-0" recreation room featured a 20'-0" clear height from the finish floor to the bottom chord of the trusses. This large open volume held a raised stage in its south end. In plan view, the approximately 27' wide 18' deep stage featured a central performance area with slight, approximately 5' wide, wings at either end. The substructure for the stage consisted of 4" x 4" wood posts carrying 2" x 10" beams. The stage rose 3'-8" above the finish floor with horizontal 1" x 4" ship-lapped V-groove wood siding and a rounded wood edge strip along the outer face of the stage. Two pairs of double-doors provided access to the chair storage area beneath the stage. Metal grilles to either side of these doors provided ventilation for the storage space.

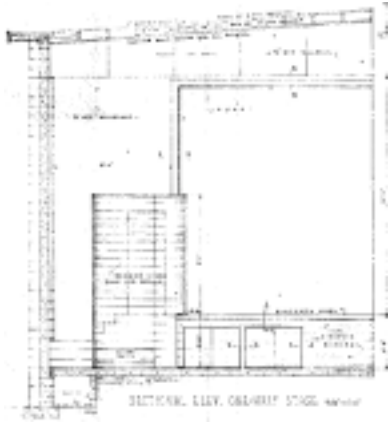
SECTION THROUGH RECREATION ROOM, LOOKING SOUTH AT EAST HALF OF STAGE. UNDATED DRAWING COURTESY OF THE WASHINGTON MILITARY DEPARTMENT.

In order to form the proscenium arch and stage opening, ½" gypboard sheathing was applied to the truss immediately over the stage to enclose the upper portion. On either side below this truss, 2"x6" stud walls sheathed in ½" gypboard extended out from the exterior building walls to enclose the performance area. The resulting stage opening was cased with ¾" x 5½" wood casings with a ½" quarter-round molding along the corners between the casings. Windows in the recreation room's south end wall provided day lighting for this staging area behind the partition walls.

Wood screens rising a little over 8' to either side of the stage opening created an additional layer of visual depth. These screens featured the same horizontal wood siding as the stage front. Quarter-turn wood stairs flanking the performance area led up to the stage.

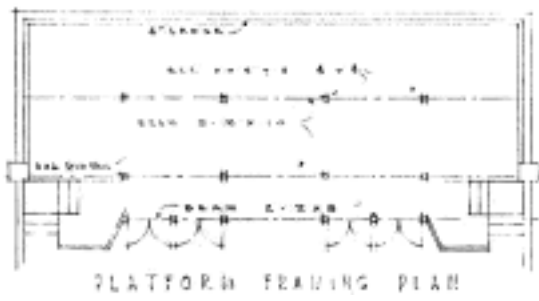
PLAN OF STAGE (SOUTH END AT TOP). UNDATED DRAWING COURTESY OF THE WASHINGTON MILITARY DEPARTMENT.

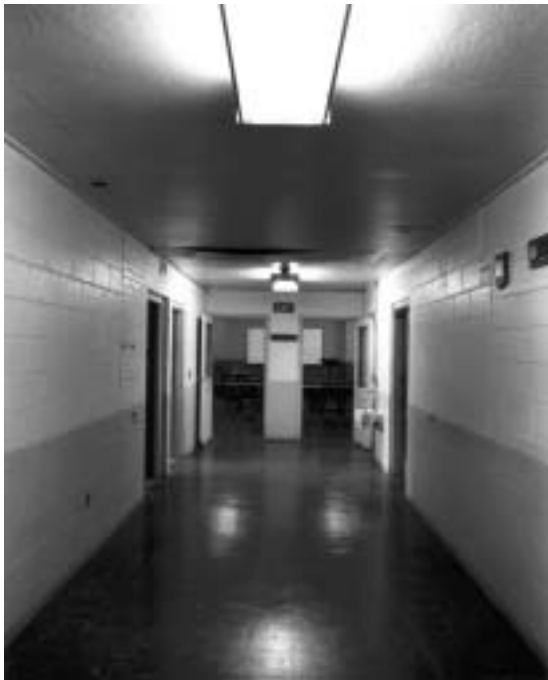
MAIN CORRIDOR, LOOKING NORTH INTO THE CLUBROOM. THE FURNACE ROOM AND KITCHEN ENTRIES ARE ON THE LEFT. IN THE IMMEDIATE RIGHTHAND PORTION OF THE PHOTOGRAPH ARE CONCRETE BLOCKS IN THE FORMER RELIGHTS BETWEEN THE PUBLIC AREA OF THE GENERAL OFFICE AND THE CORRIDOR. PHOTOGRAPH BY TERRY RISHEL (SEPTEMBER 2002).

In the building's one-story volume, the main 9'-0" wide corridor leading north from the lobby facilitated circulation amongst the office, public and service spaces. Relights in the east wall of the corridor enabled light sharing from the public area of the general office. A water fountain was located on the east side of the corridor's north end for public use.

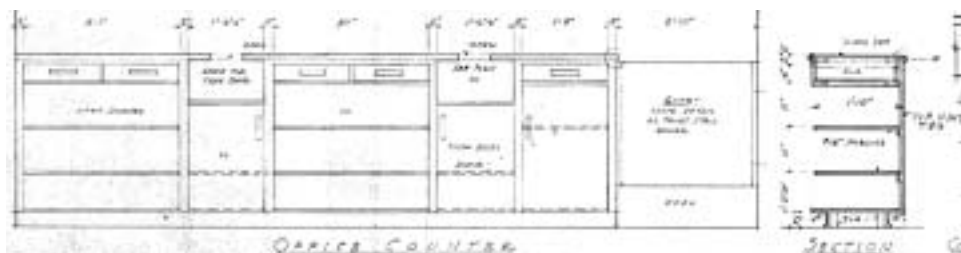
DETAIL OF COUNTER BETWEEN GENERAL OFFICE AND PUBLIC AREA FROM PERSPECTIVE OF OFFICE. UNDATED DRAWING COURTESY OF THE WASHINGTON MILITARY DEPARTMENT.

Office space was located on the front of the building in the central wedge section. The 23'-6"x12'-8" general office off the lobby and main corridor provided administrative support for both the community and the activities held in the building. Public and staff interaction took place in a public area on the office's west end directly off the north side of the lobby. A counter along the length of this area having a 6"x12" wood beam overhead provided the forum for this interaction. Cash drawer spaces were recessed into the counter, each with a 7½" wide partial opening in the linoleum counter top. The public side featured a hardwood molding along the counter edge. On the office side, two small 4" tall drawers directly below the counter with three large open shelves below provided storage with a single 4" tall drawer with one large cupboard below at the north end of the counter and a swinging door between the spaces. Within the office space, the ceiling sloped up and out towards the exterior wall and windows. A vault was located off the northwest corner of the general office.

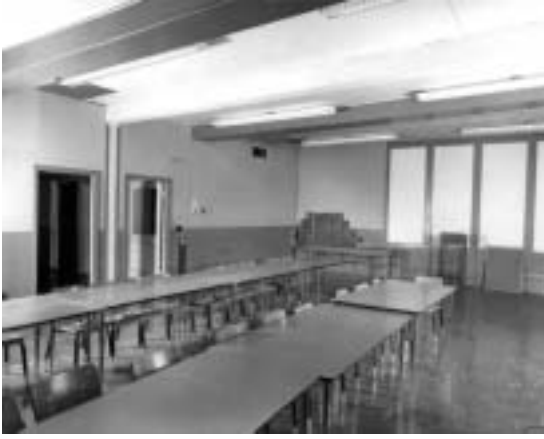
CLUBROOM, LOOKING SOUTHWEST. THE WINDOWS WERE BOARDED OVER AND THE FOLDING PARTITION DOOR REMOVED. PHOTOGRAPH BY TERRY RISHEL (SEPTEMBER 2002).

The north end of the one-story volume featured two rooms, a 28'-10"x43'-4" clubroom and a 9'-4"x16'-0" kitchen. A folding partition wall within the clubroom could be pulled across the middle of the room to subdivide it into two smaller rooms. The room's ceiling sloped up from the ceiling height of the corridor expanding out

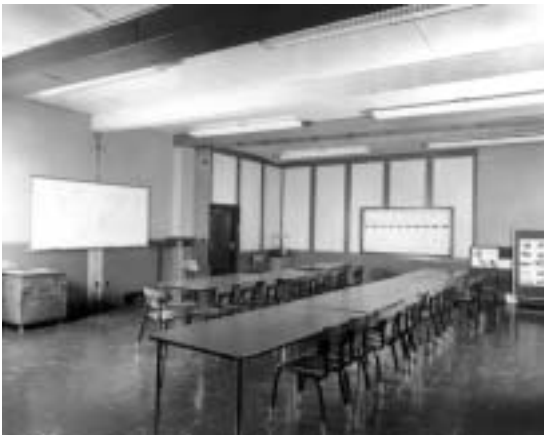
CLUBROOM, LOOKING NORTHEAST. THE LIGHTING WAS CHANGED AND THE WINDOWS BOARDED OVER. PHOTOGRAPH BY TERRY RISHEL (SEPTEMBER 2002).

towards the windows on the north wall. Stacked wood lockers, each 3'-1¼" tall with shelves inside, lined the east end of the south wall.

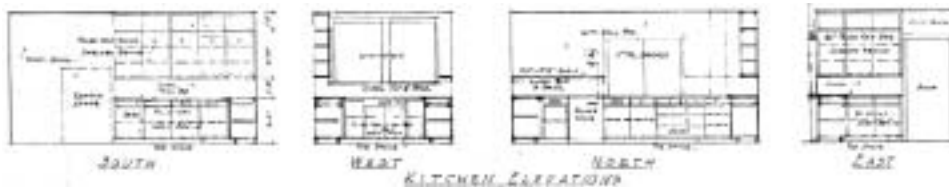
FIG. 34. DETAIL OF COUNTERS IN KITCHEN. UNDATED DRAWING COURTESY OF THE WASHINGTON MILITARY DEPARTMENT.

The kitchen was entered from the east off the main corridor and featured a pass through service counter to the clubroom in its north wall. Within this narrow, rectangular kitchen, community members prepared food for events held in the building. Linoleum counters with a hardwood edging and 1'-4" high linoleum backsplash extended along the north, west and south walls. Directly below the counters were drawers, and on the north wall there was a pull board. Storage space consisted of cupboards, both below and overhead, with flush panel doors. The kitchen was also equipped with a refrigerator, a range and a sink, the latter below the two windows on the west wall.

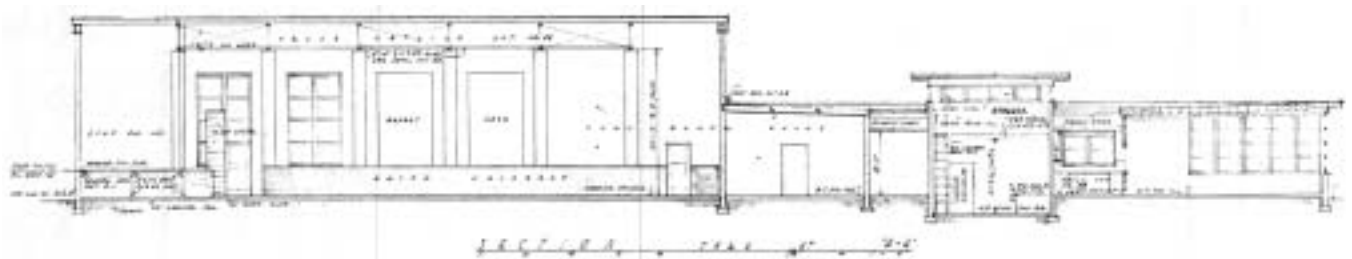
SECTION THROUGH BUILDING LOOKING WEST. UNDATED DRAWING COURTESY OF THE WASHINGTON MILITARY DEPARTMENT.

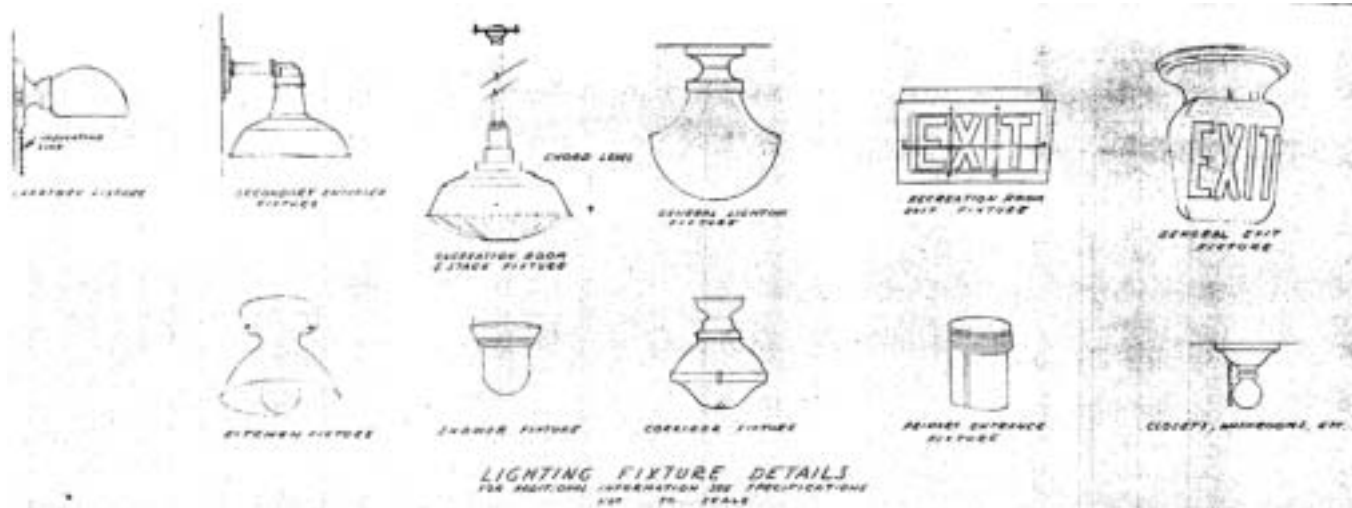
DETAIL OF INTERIOR AND EXTERIOR FIXTURES. UNDATED DRAWING COURTESY OF THE WASHINGTON MILITARY DEPARTMENT.

Hardware and fixtures were largely plain and utilitarian.

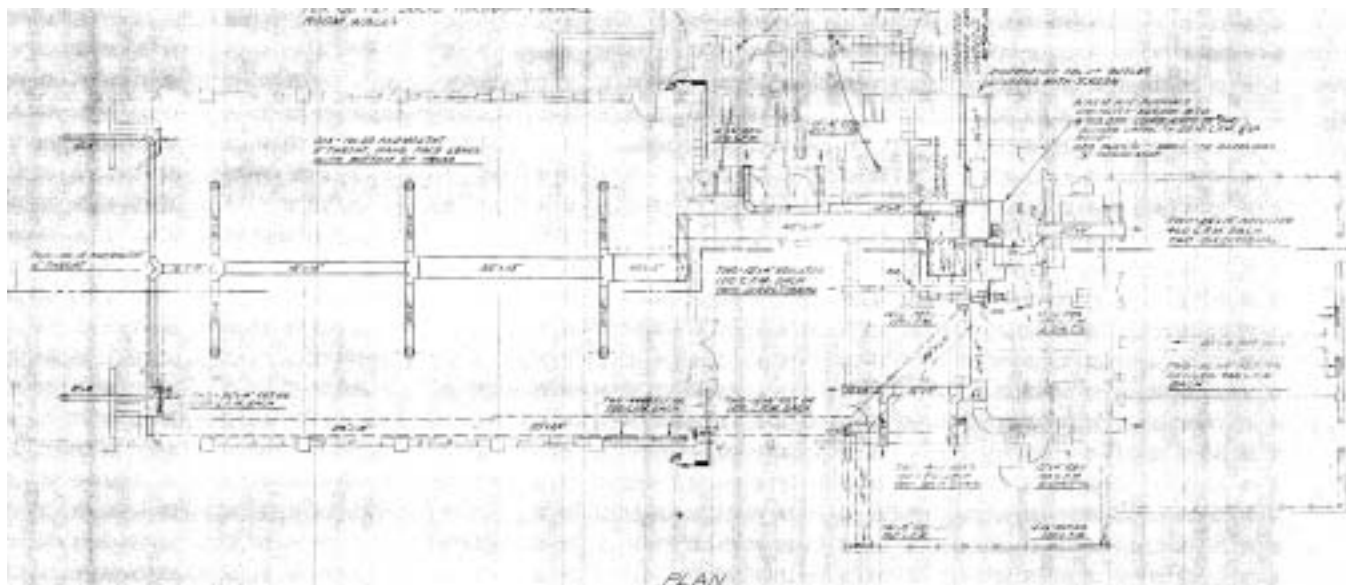
DETAIL OF DUCTWORK. UNDATED DRAWING COURTESY OF THE WASHINGTON MILITARY DEPARTMENT.

Heating for the building was provided by a coal-fired warm air furnace with a 525,000 B.T.U. capacity run on a bottom-fed automatic stoker that drew coal from the fuel storage area into the furnace. A blower distributed the warm air through ductwork running above the furred out one-story volume ceilings to each room, and by exposed sheet metal duct work in the recreation room. Cold air returns were provided both in the furred out spaces and beneath the slab in the recreation room, clubroom and offices. Concrete ducts ranged in size from 24"x12" to 30"x24". A fresh air intake extended through the one-story roof. The ductwork over the recreation room branched from a main trunk with successively smaller trunk and branch sizes to provide total coverage including the stage area. Exhaust fans above the showers vented steam through the roof.

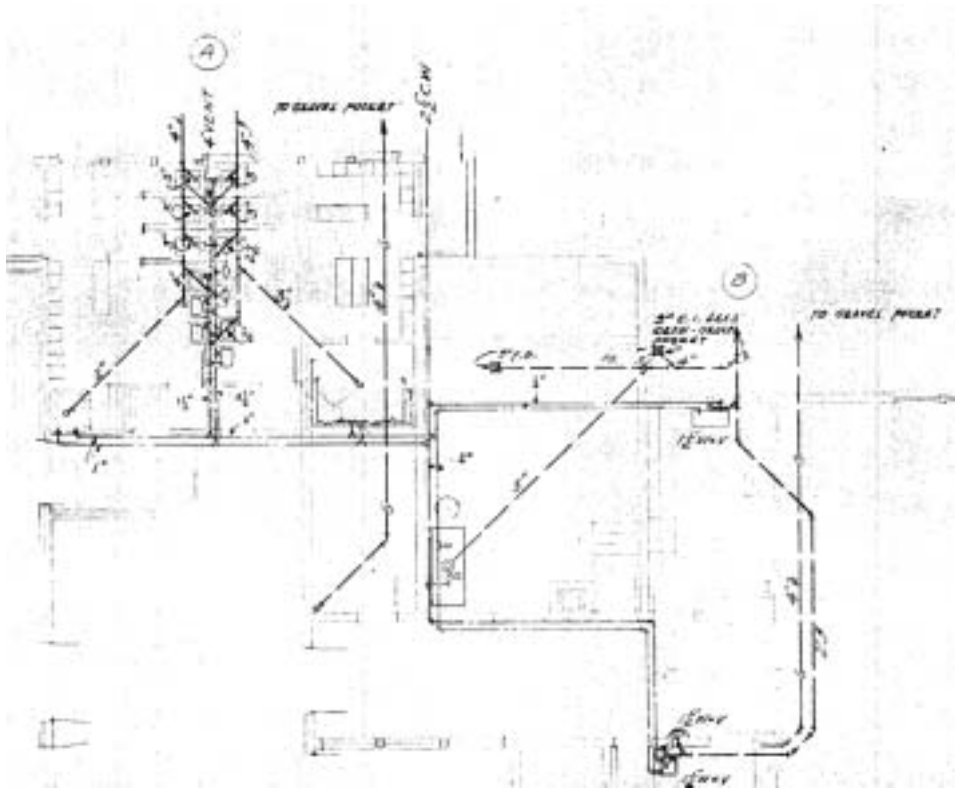
DETAIL OF PLUMBING. UNDATED DRAWING COURTESY OF THE WASHINGTON MILITARY DEPARTMENT.

An 800-gallon capacity coal-fired hot water heater met the building's hot water needs. Plumbing consisted of smaller shower, sink and toilet lines joining a 4" in diameter main line running west from the restrooms. The smaller lines coming from the water fountain, janitor's and kitchen sinks, as well as the 3" floor drains in the furnace room, joined another 4" in diameter line and were routed west. The building was fully wired for lighting, electrical outlets and for the electric range in the kitchen.

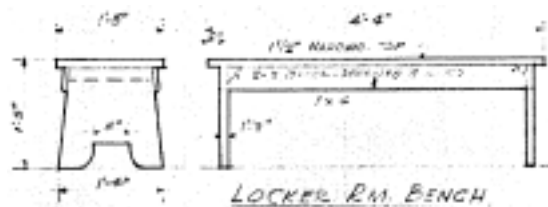
FIG. 42. DETAIL OF RESTROOM BENCHES. UNDATED DRAWING COURTESY OF THE WASHINGTON MILITARY DEPARTMENT.

Furnishings were relatively sparse. Those indicated in the drawings consisted of a chair truck and locker room benches. Each chair truck featured plywood decking with four swivel caster wheels, and a 2"x4" frame. The 8'-0"x3'-8" frame was mortise and tenoned, and glued with hardwood dowels. Each of the locker room benches was 4'-4"x 1'-5" in size with a hardwood top.
